# BOEING SCIENTIFIC RESEARCH LABORATORIES

## The Analysis of Fracture Surfaces by Electron Microscopy

Regis M. N. Pelloux

December 1963

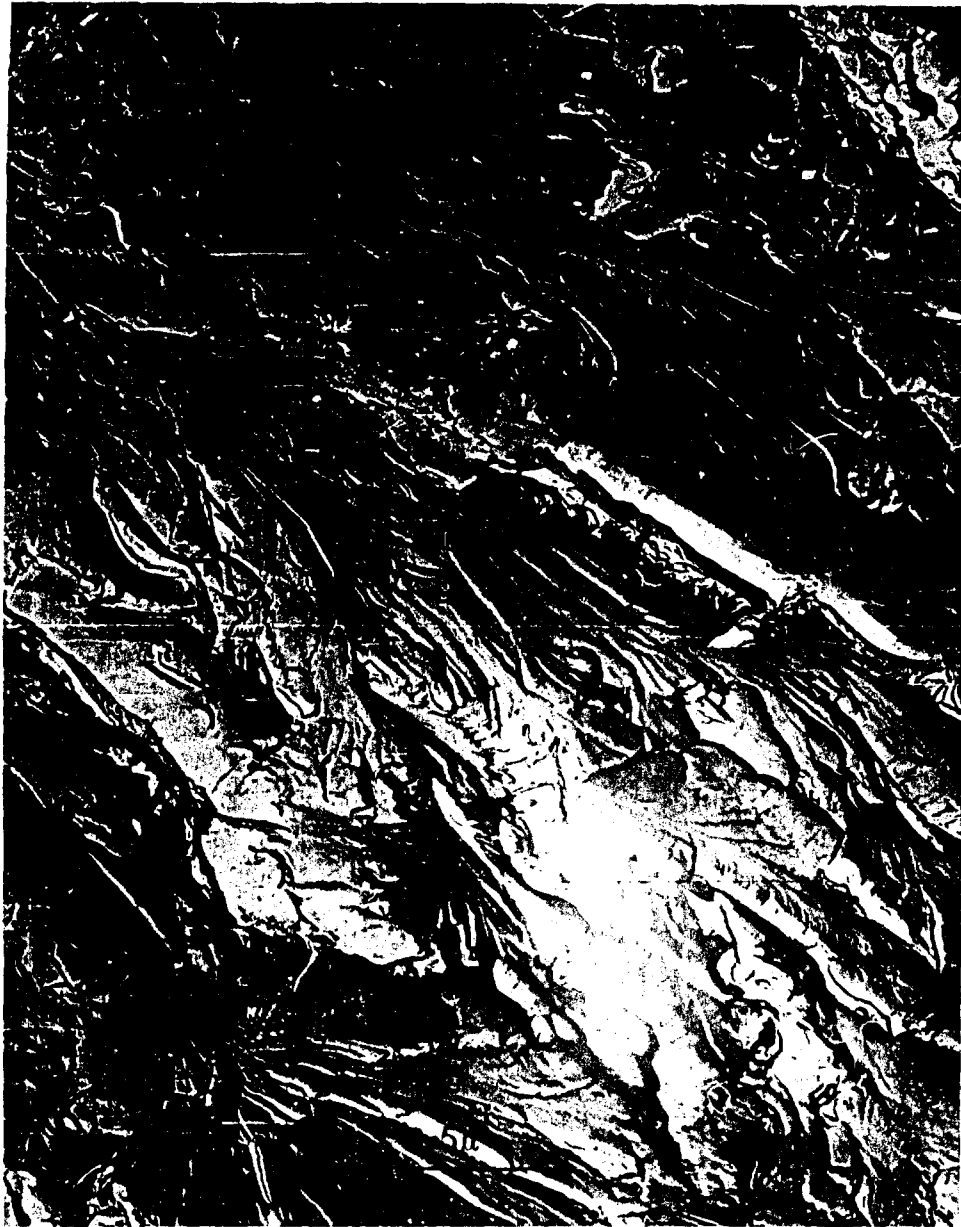
Figure 3b

- CLEAVAGE FRACTURE. Cleavage fracture in a TZM molybdenum alloy. The large cleavage "feathers" are made up of many cleavage facets. Extensive tear takes place between the large regions of cleavage (two step replicas).

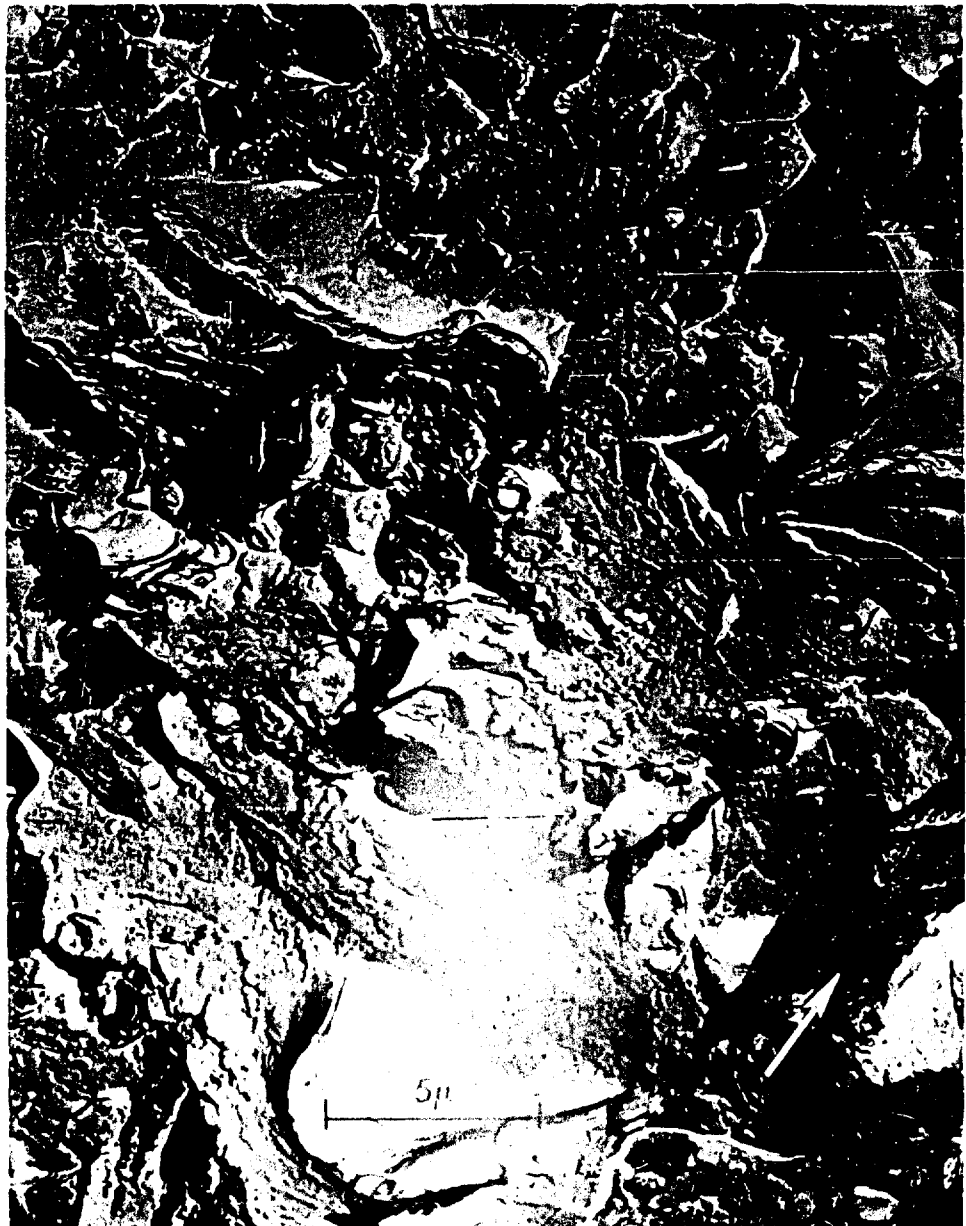
Figure 15

- QUASI CLEAVAGE - Fracture surface of a 4335 steel showing quasi-cleavage. The surface is made up of shallow dimples and small cleavage facets, (two step replica).

Figures 11, 12, 13 and 14 illustrate the different sizes and shapes of dimples observed in some common materials. In age hardening alloys such as the aluminum alloys or the maraging steels where most of the second phase particles are coherent with the matrix, it is evident that the size of the dimples is much larger than the spacing between the precipitates. In steels such as 4340, it has been observed that the higher the fracture toughness, the larger the dimples. This shows that only a limited number of inclusions or precipitates act as crack nucleation sites ahead of the main crack front, and that this number depends on the overall velocity of propagation of the crack. Irwin<sup>(11)</sup> concludes from his observations that an increase in crack velocity is accompanied by an increase in the number of microcracks which are initiated closer and closer to the main crack front. For steels, it is known that the transition from a ductile to a brittle (cleavage) fracture corresponds to a marked increase in the speed of propagation of the crack front. Although it is easy to identify by electron fractography, a true cleavage fracture or a perfect plastic fracture, the features of a ductile-brittle fracture are not very well understood. The expression "quasi-cleavage" is usually employed to describe this type of fracture illustrated by Figure 15. Beaches<sup>(7)</sup> shows that it is

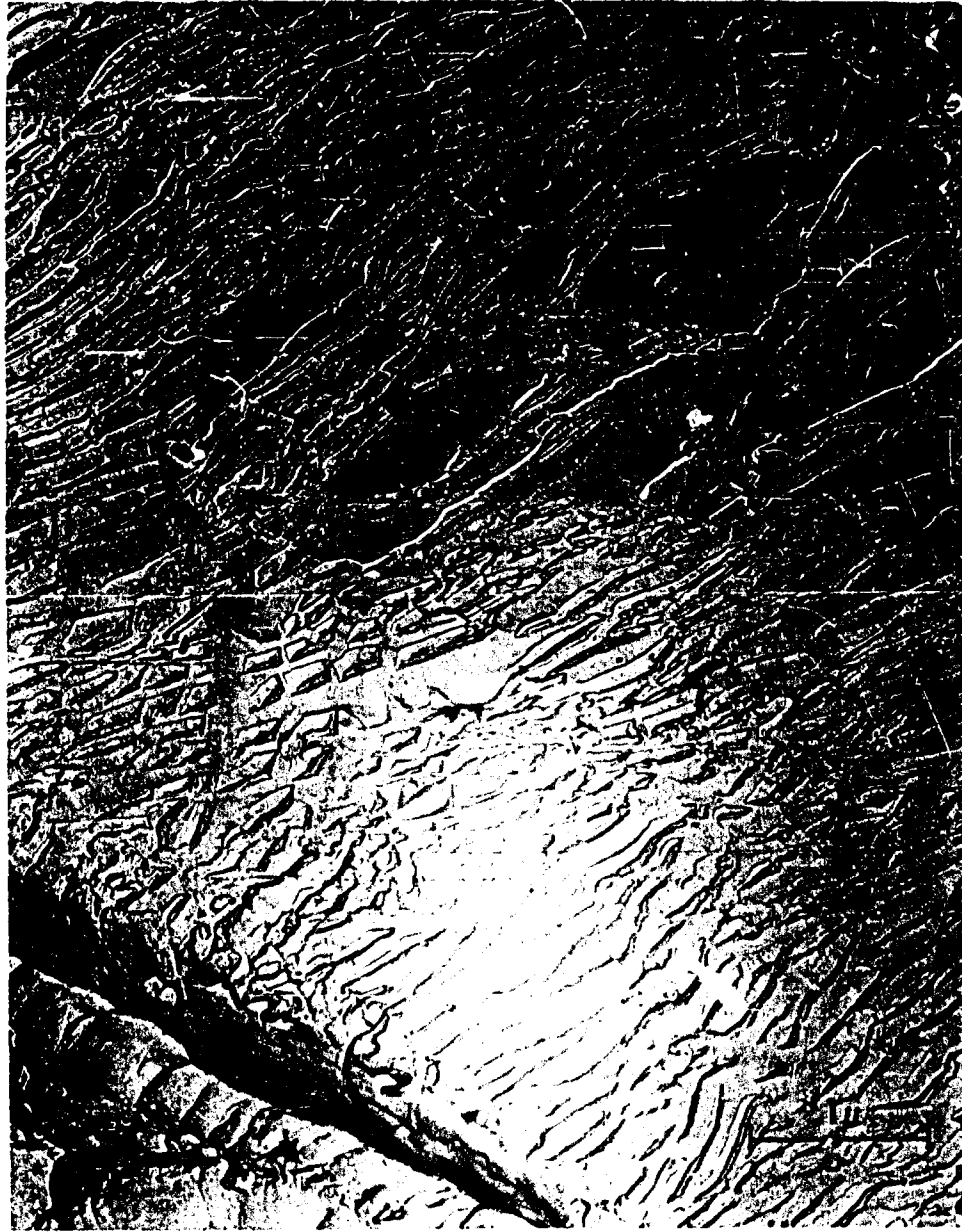
Figure 21 - INTERGRANULAR FRACTURE - Brittle intergranular fracture and network of carbides along the grain boundary facet in AM335. (two step replica)

had been embrittled by intergranular carbide precipitation. They found that the grain boundary film does not have to be continuous to produce intergranular fracture. The fracture was observed to occur at the carbide matrix interface or sometimes by cleavage at the carbide plate. Figure 21 shows an example of an intergranular fracture in AM355 due to  $M_{23}C_6$  carbides.

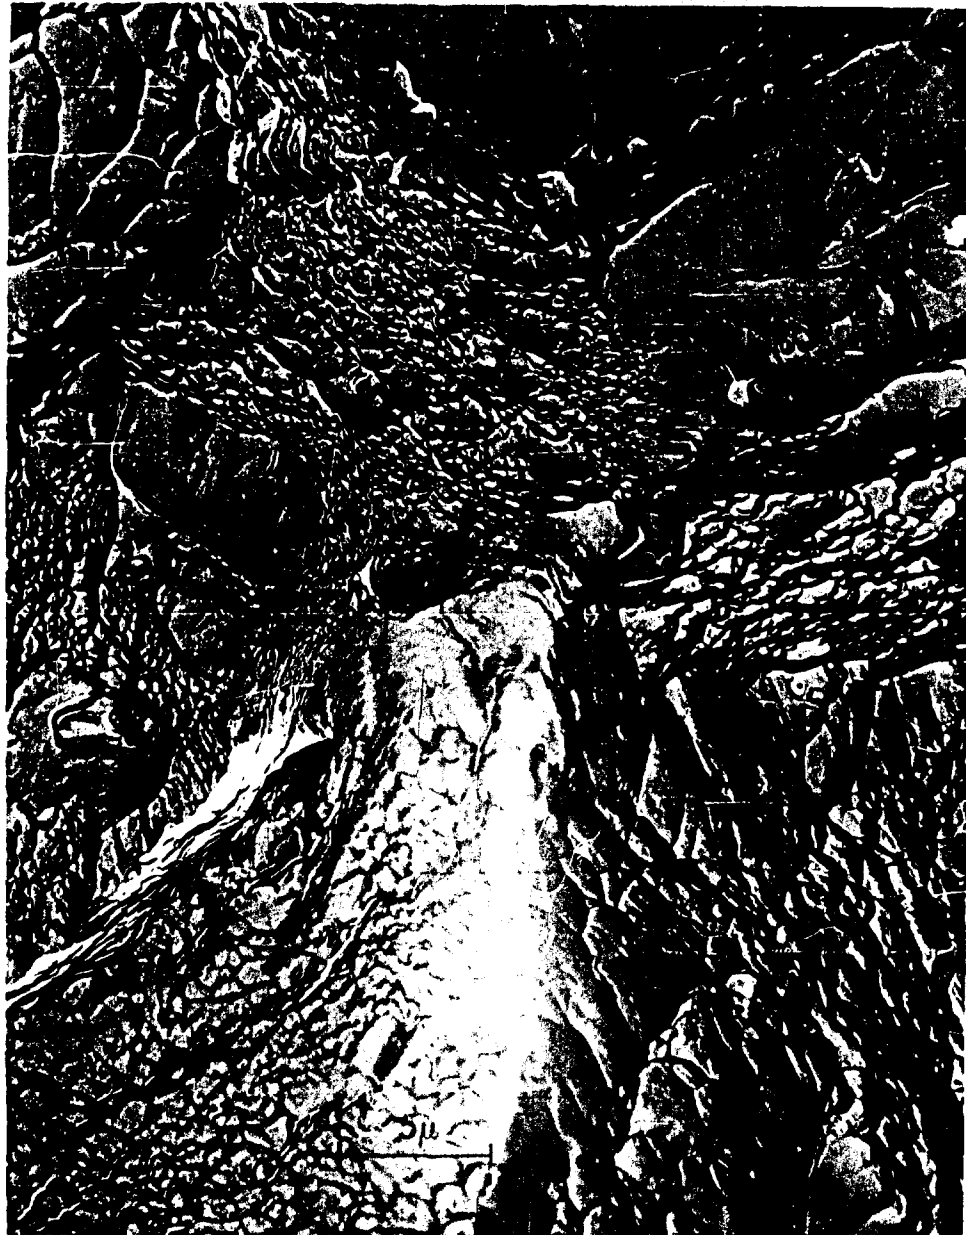
Figure 25 - INTERGRANULAR FRACTURE - Plastic intergranular fracture in a 2219 alloy. The difference in orientation of the grain boundary facets is well marked and the shear direction is given by the direction of elongation of the dimples. (two step replica)

A second mode of grain boundary separation is the plastic intergranular fracture. The separation along the grain boundaries is accompanied by an extensive shear deformation and formation of elongated shear dimples. Figures 24 and 25 show a plastic grain boundary fracture in a 2219 aluminum alloy. This type of fracture is usually connected with the well-known delamination fracture of some aluminum alloys which result from a depletion of second phase precipitates along the grain boundaries. Another example of plastic intergranular fracture takes place during creep at high temperatures when voids form along grain boundaries by diffusion of vacancies.

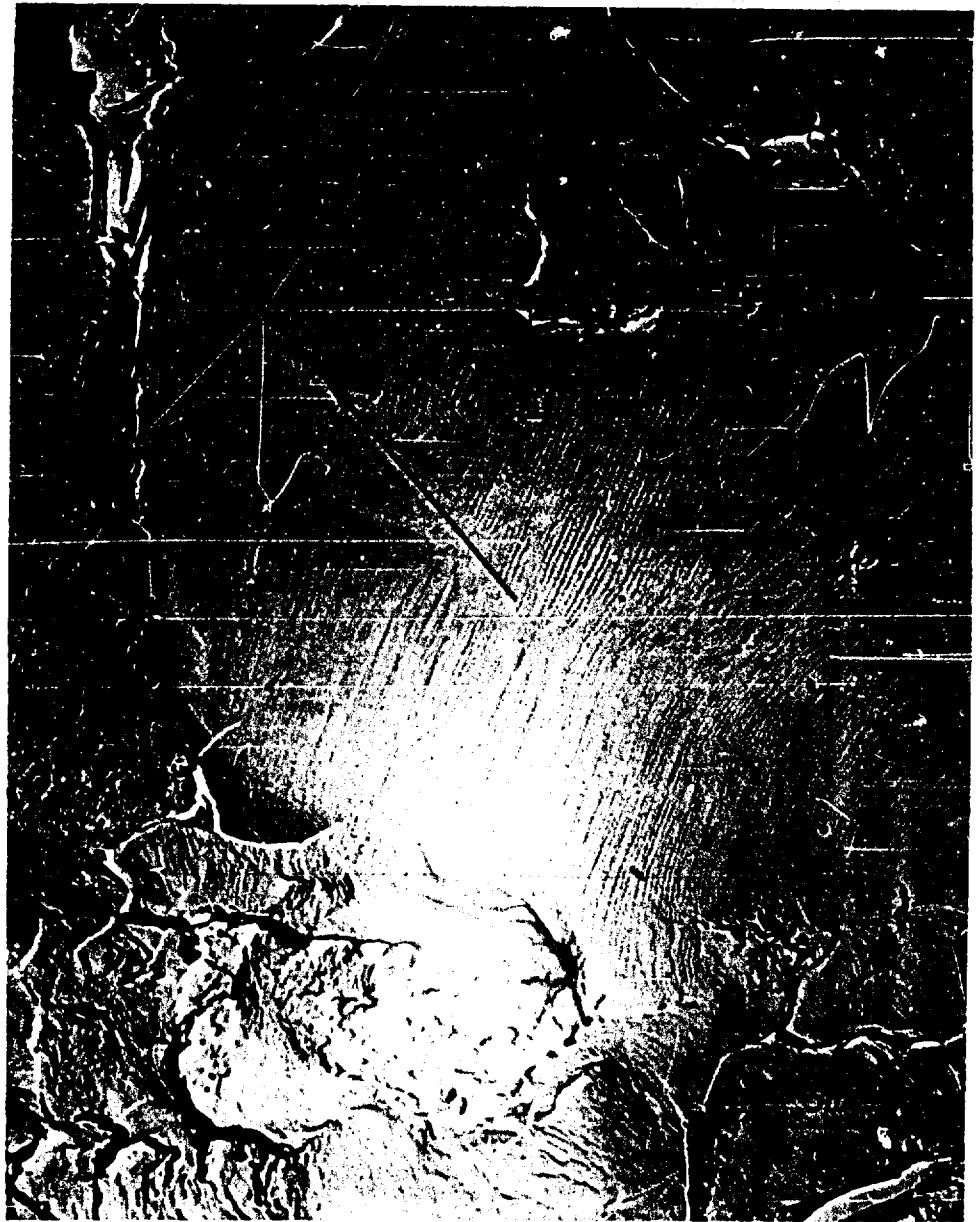
Figure 34

- FATIGUE FRACTURE - Fatigue striations in Ti - 6 Al -  
4 V alloy (two step replica).

Other examples of fatigue striations are shown on Figures 33, 34, 35 and 36. In general, the striations in different materials are not as sharply defined as they are in high strength aluminum alloys. In steels for instance, the successive positions of the crack front do not appear clearly defined; the striations are short and discontinuous. Very often, according to the ratio of the maximum to the minimum stress, the details of the fracture surface have been destroyed by the rubbing action of the two fracture faces.
